Investigation of the UH-60 Main Rotor Spindle Assembly Retaining Rods P/N 70102-08102/-103

ARL-TR-1585

January 1998

The purpose of this investigation was to determine the root cause of the differences seen in the fatigue test data of UH-60 main rotor spindle assembly retaining rods from three different vendors.

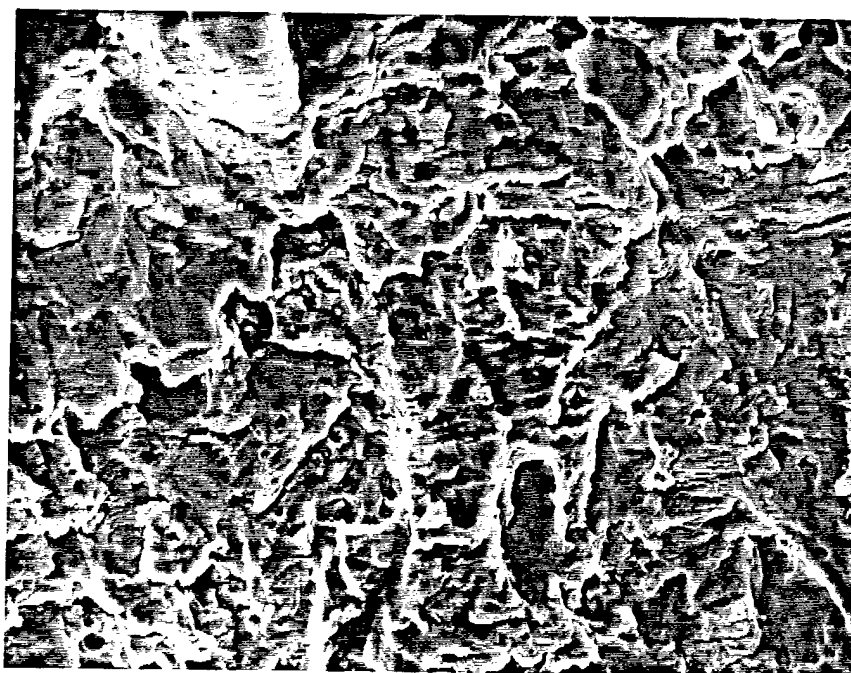
Figure 87. The Transgranular Morphology Representative of the Fatigue Zones of PUR Tie Rod -174 (Mag. 1kx).

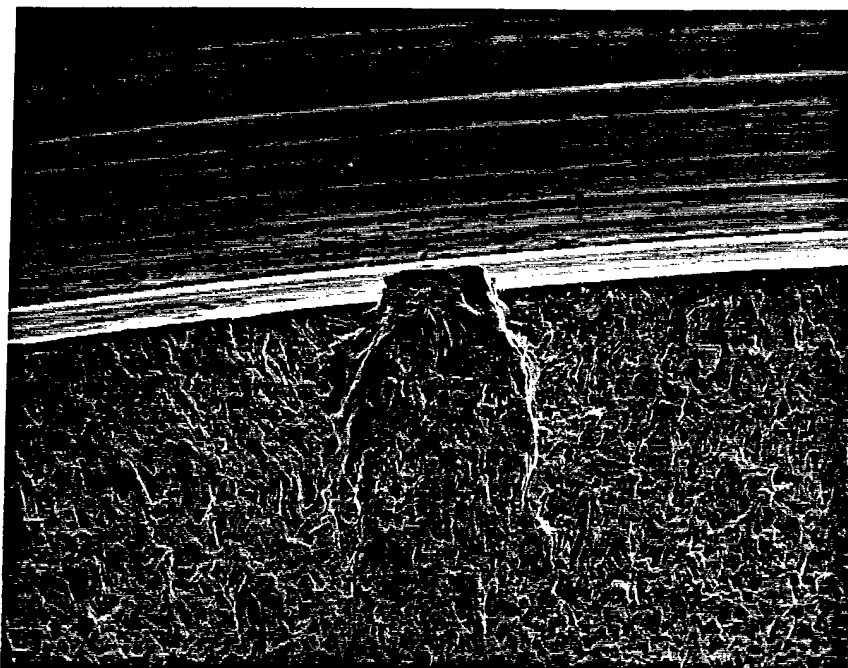
Figure 92. A Typical Origin of PUR Rod -177 (Mag. 100×).

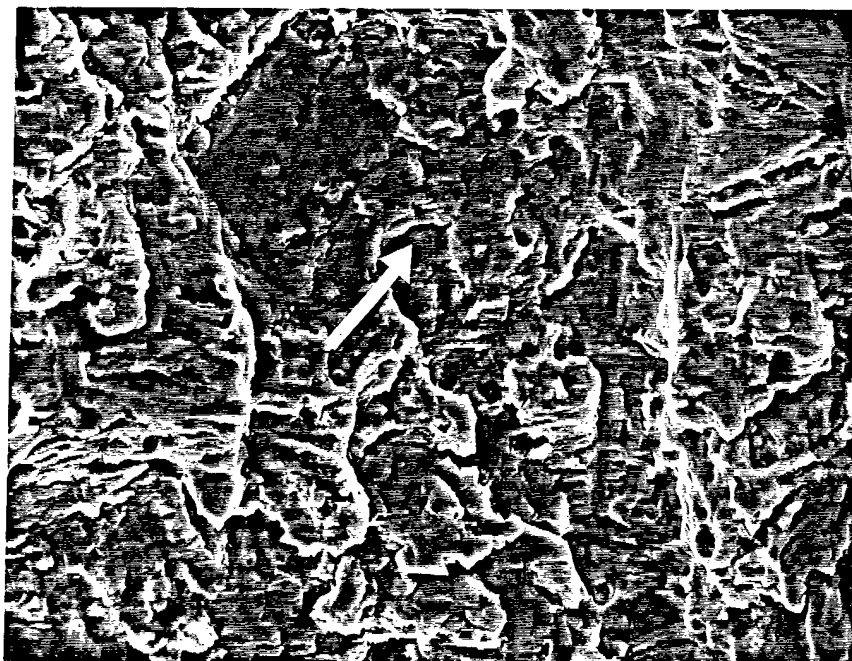
Figure 93. A Transgranular Cyclic Fatigue Morphology Observed Within the Fracture Surface of PUR Rod -177. Note the Fatigue Striations (Mag. 1kx).

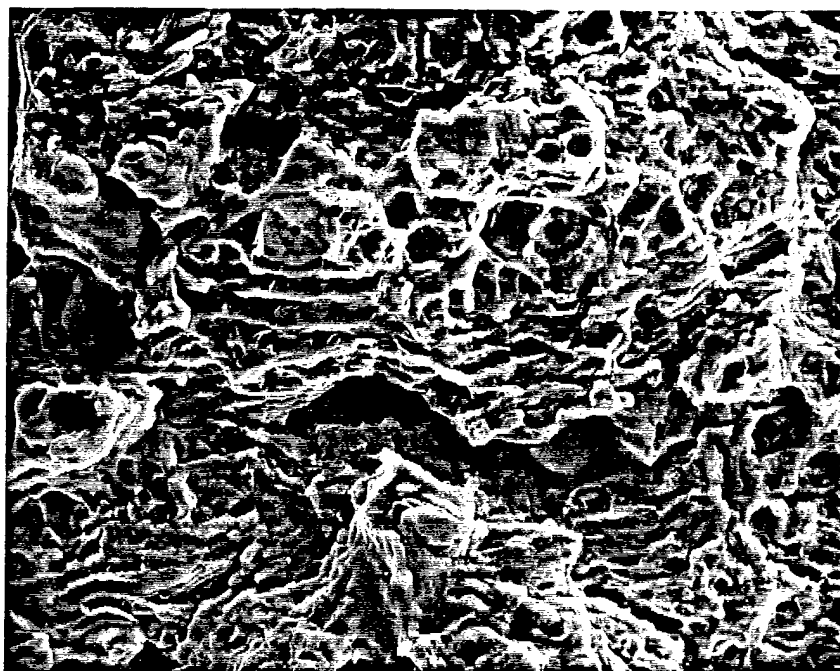
Figure 94. A Transgranular Morphology Mixed With Tearing on the Fracture Surface of PUR Rod -177 (Mag. 1kx).

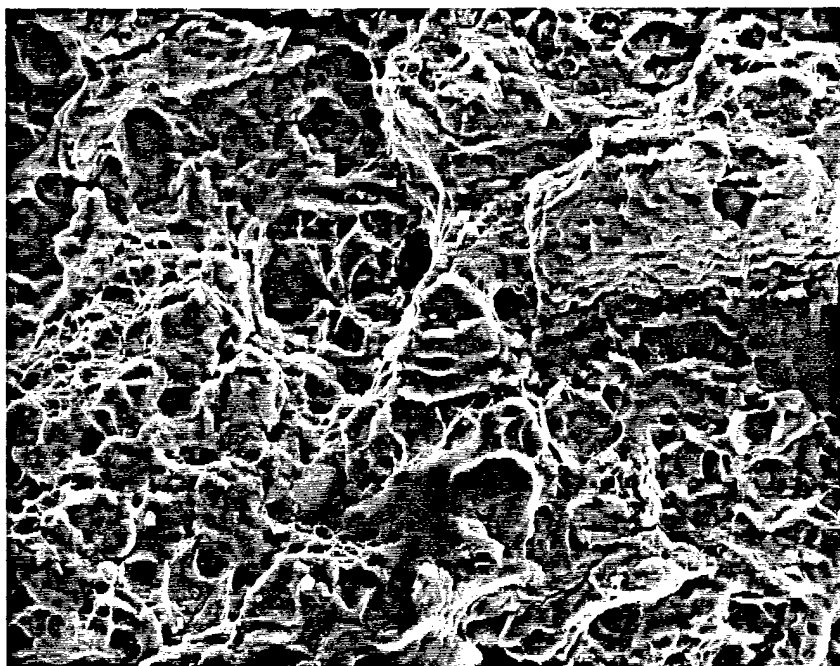
Figure 95. The Morphology of PUR Rod -177 Consisting of Striations Mixed With Ductility (Mag. 1kx).

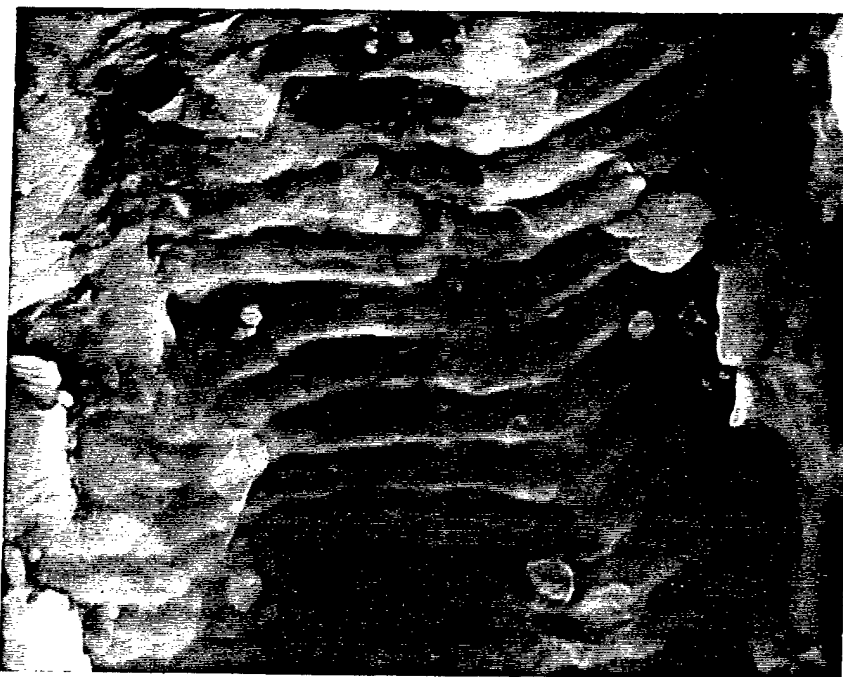
Figure 100. Striations Noted on PUR Rod -177, Note How Spacing Is Increasing From Figure 98 and 99 (Mag. 10kx).

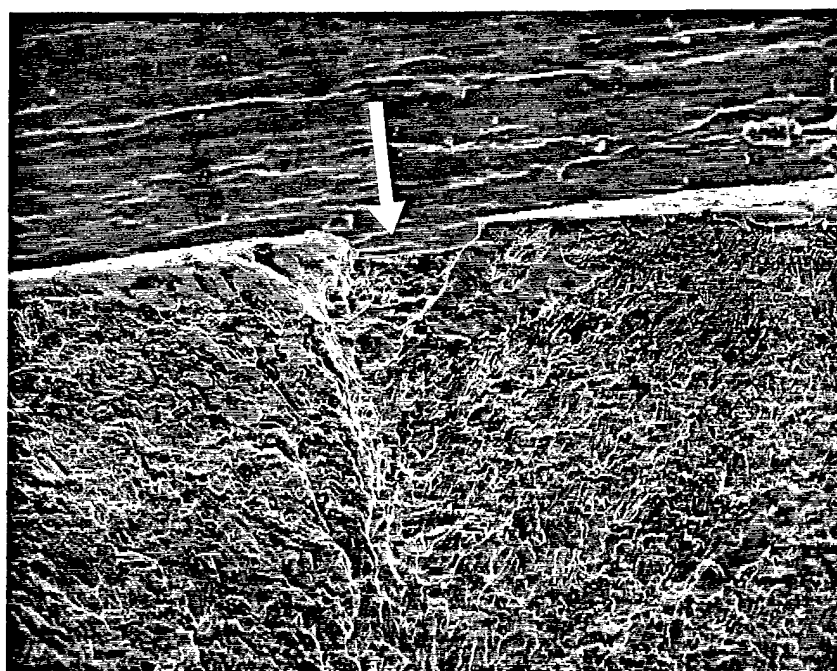
Figure 103. A Typical Origin on the Fracture Surface of S&S Tie Rod -2 (Mag. 150x).

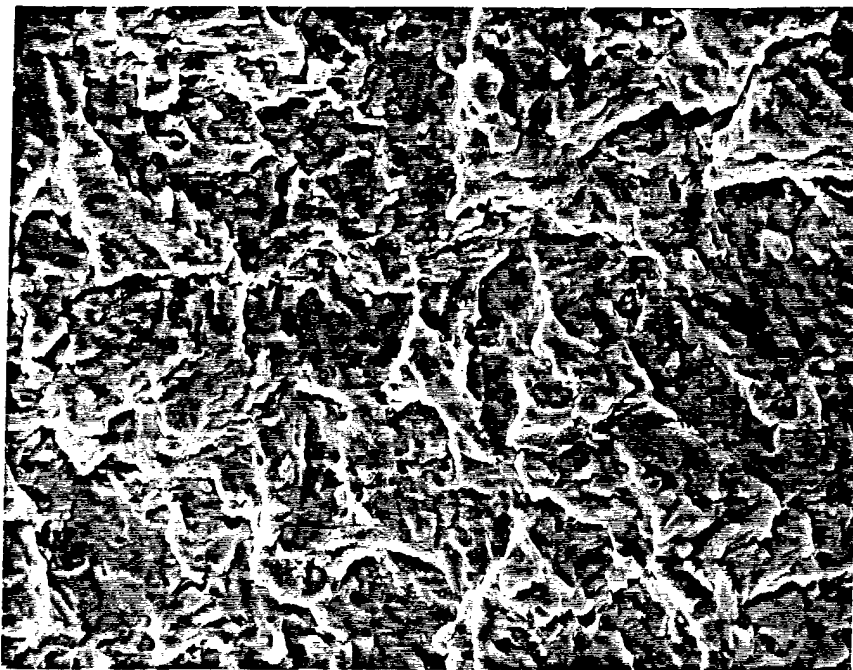
Figure 104. Typical Transgranular Morphology of S&S Rod -2. This Morphology Was Characteristic of Fatigue (Mag. 1kx).

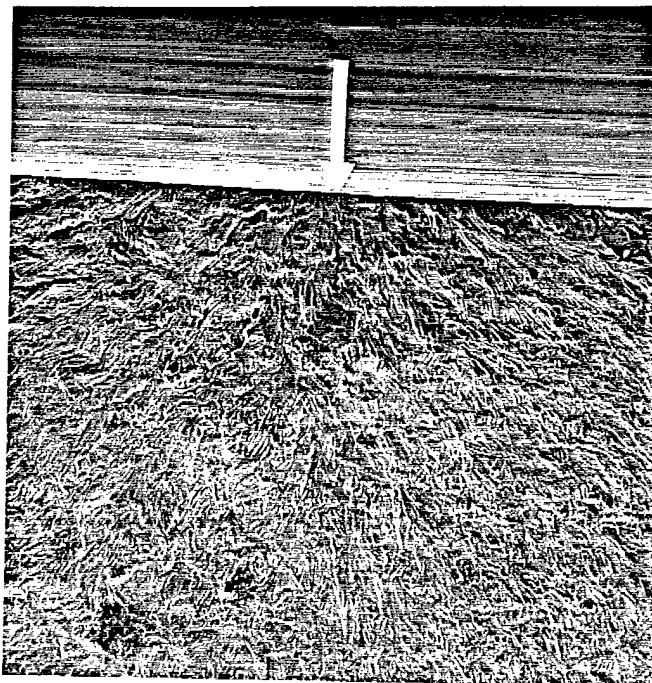
Figure 107. Typical Origin Noted on the Fracture Surface of the S&S Rod -3 (Mag. 200x).

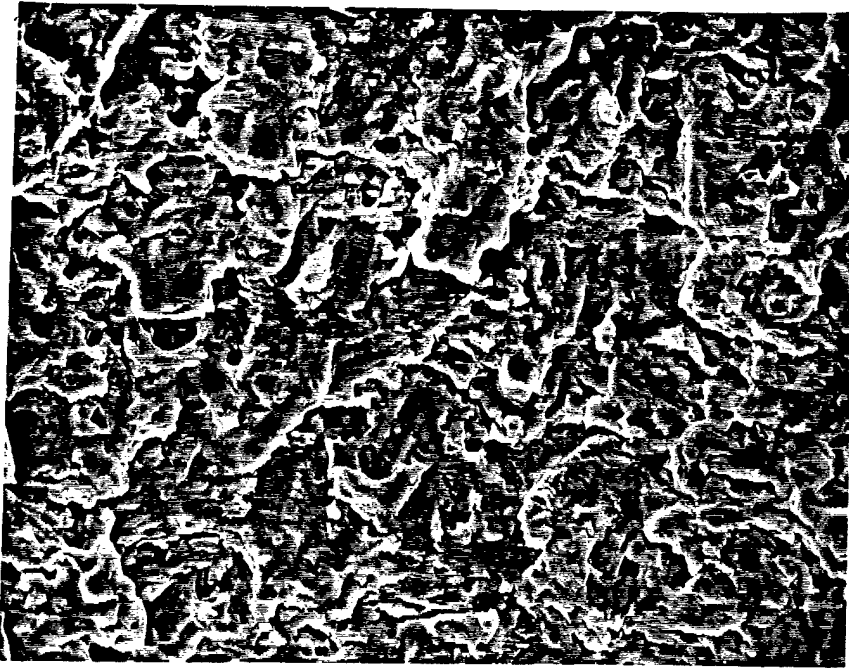
Figure 108. The Transgranular Morphology Contained Within the Fatigue Zone of the S&S Tie Rod -3 (Mag. 1kx).
